IMPACT OF SOIL PROPERTIES AND FLOW VELOCITY ON RIVER BANK EROSION IN NAGAON DISTRICT ACROSS TWO SEASONS

MASTERS OF TECHNOLOGY

(With Specialization in Water Resource Engineering)

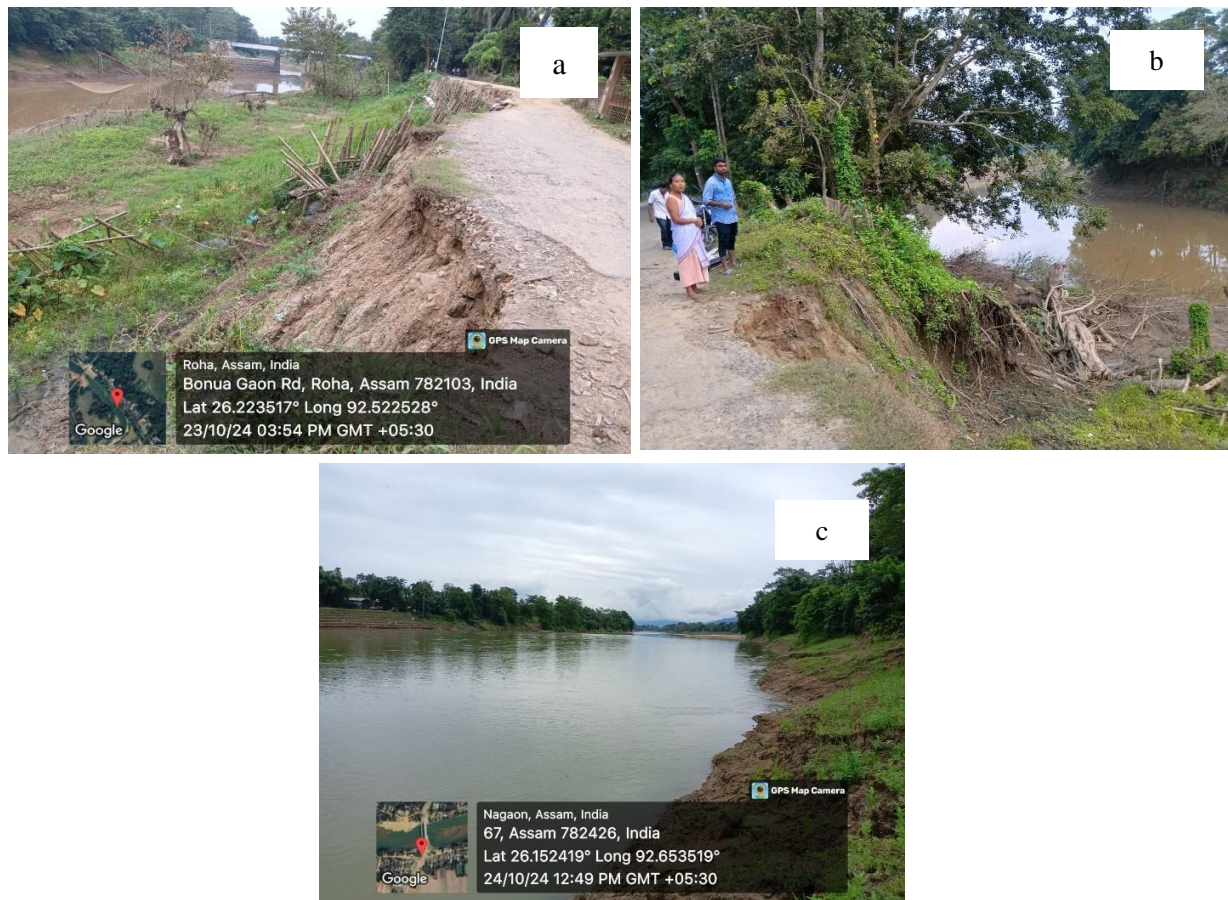
Fig 1.1: Photo shows erosion of river kolong and kopili in (a) Rahachoki (b) Borchung and (c) Jorabari

The fine sand and silty nature of the river bank material and the unstable bank line along the most part of the river create a highly favorable environment for bank erosion. The bank materials in the Brahmaputra are highly susceptible to erosion by the river due to their high moisture content, low clay content and poorly graded fine sand and silt.

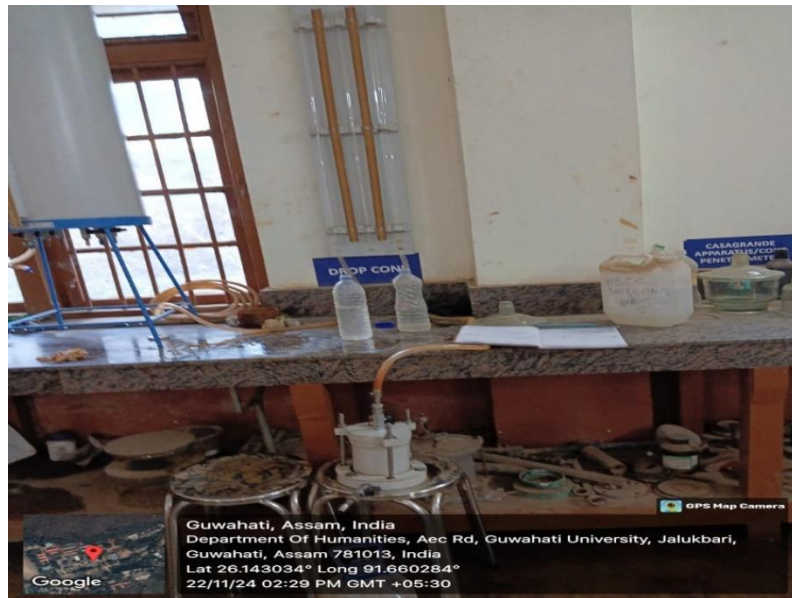
Fig 4.3: Falling head permeability test

The falling head test is used for relatively less permeable soils where the discharge is small. A stand pipe of known cross-sectional area "a" is fitted over the permeameter and water is allowed to run down. The water level in the stand pipe constantly falls as water flows. Observations are

started after steady state of flow has reached. The head at any time instant "t" is equal to the difference in the water level in the stand pipe and the bottom tank. Let h_1 and h_2 be heads at time intervals t_1 and t_2 ($t_1 > t_2$) respectively. The co-efficient of permeability is determined as

$$K = 2.303(aL/At) \log_{10}(h_1/h_2) \dots \dots \dots (i)$$

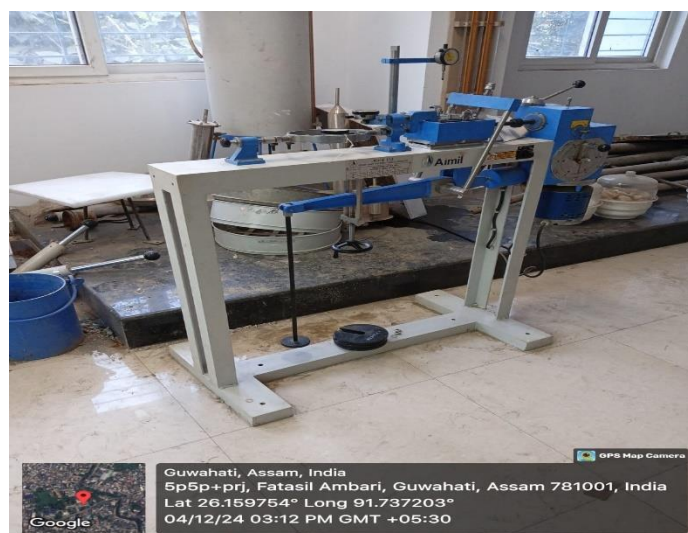
Fig4.4: Direct Shear Test

To facilitate the remolding purpose, a soil sample may be compacted at optimum moisture content in a compaction mould. Then specimen for the direct shear test could be obtained using the correct cutter provided. Alternatively, sand sample can be placed in a dry state at a required density, in the assembled shear box. A normal load is applied to the specimen and the specimen is sheared across the pre-determined horizontal plane between the two halves of the shear box. Measurements of shear load, shear displacement and normal displacement are recorded from the dial gauge and the proving ring connected to the shear box. A graph of shear stress against displacement is plotted in a normal graph paper. From this graph, the highest values of shear stress for loads 0.5 kg, 1 kg and 1.5 kg are determined. Then another graph is plotted for these maximum shear stresses against normal stresses. From this graph, the value of cohesion and angle of internal friction of the soil sample is determined. The test is repeated for two or more identical specimens under different normal loads. From the results, the shear strength parameters can be determined.

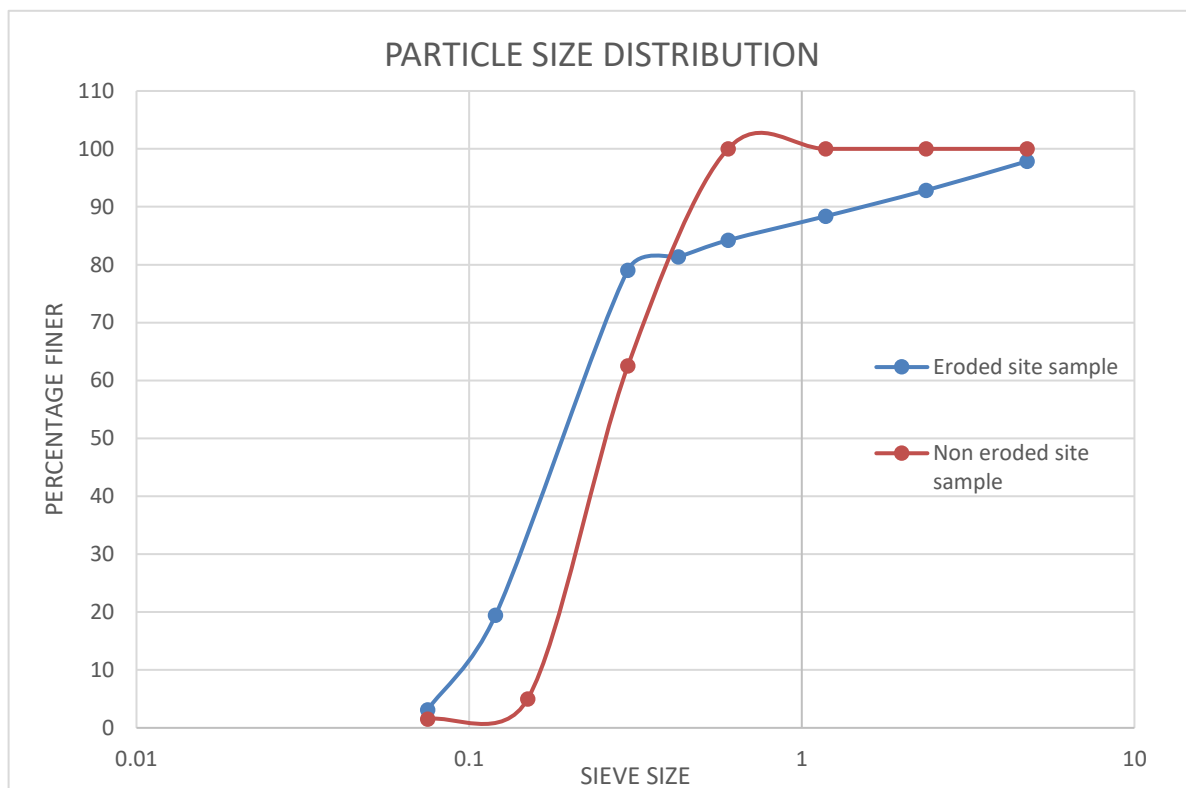
Fig 5.1: Particle size distribution of eroded and non-eroded sample

After the analysis of particle size distribution of soil sample from both eroded and non eroded sites, it was found that C_u and C_c of eroded sample were 3.75 and 1.67 respectively and 6.72 and 2.84 respectively for non-eroded samples. These findings are summarized below in table 5.1

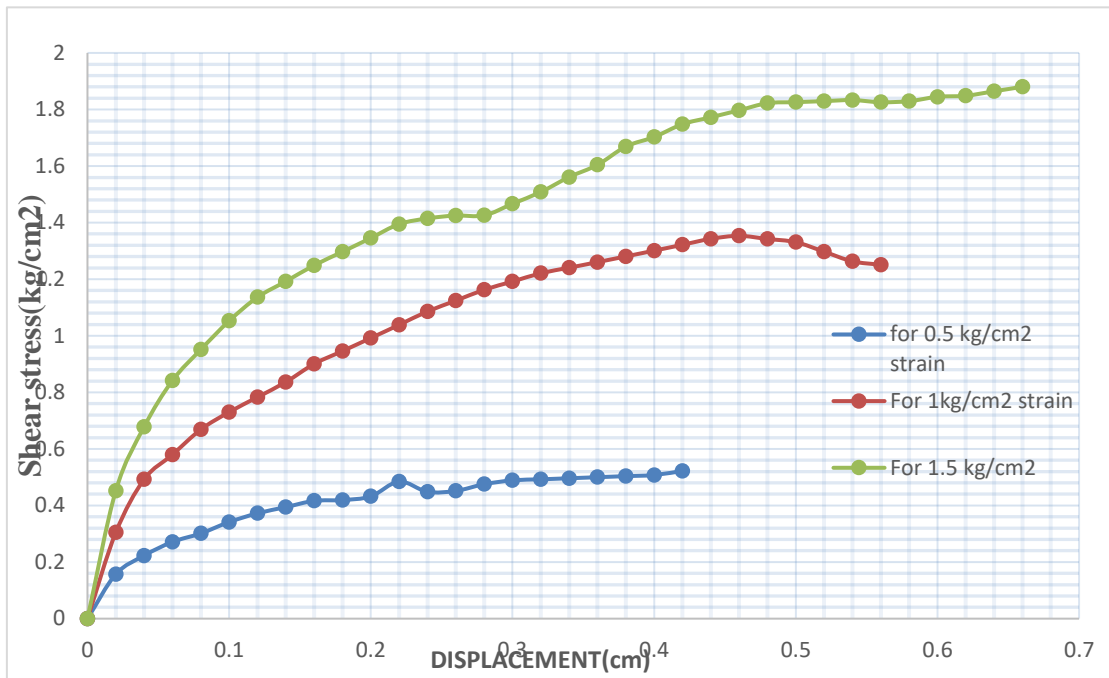
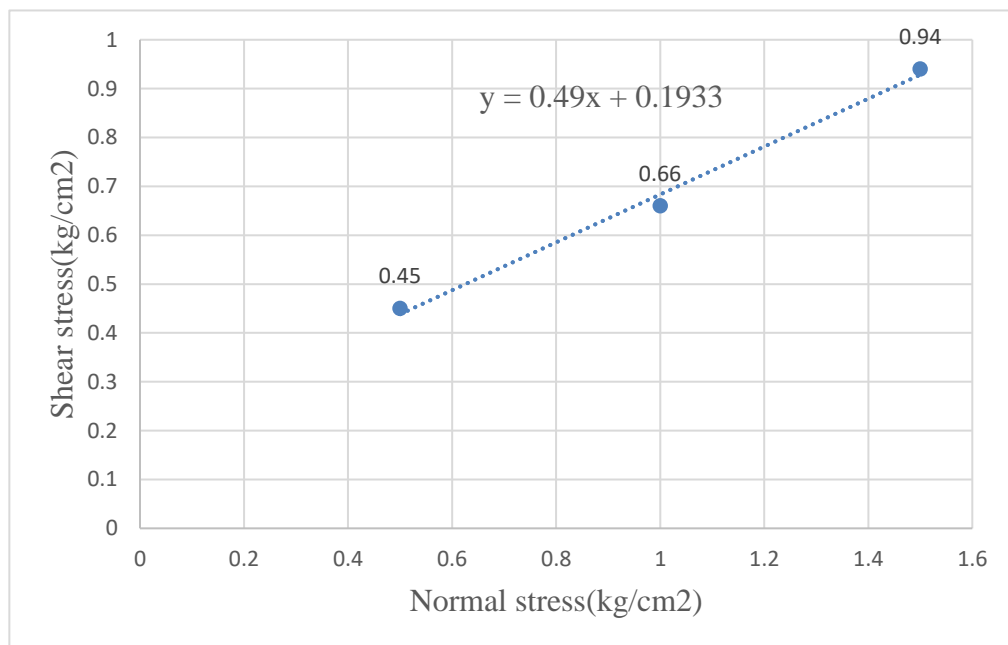
Fig 5.5: (a) Shear stress vs Displacement curve (b) Shear stress vs Normal stress curve for eroded sample

Sample	Eroded	Non eroded
C(kg/cm)	0.19	0.06
ϕ	26.10 °	29.2°

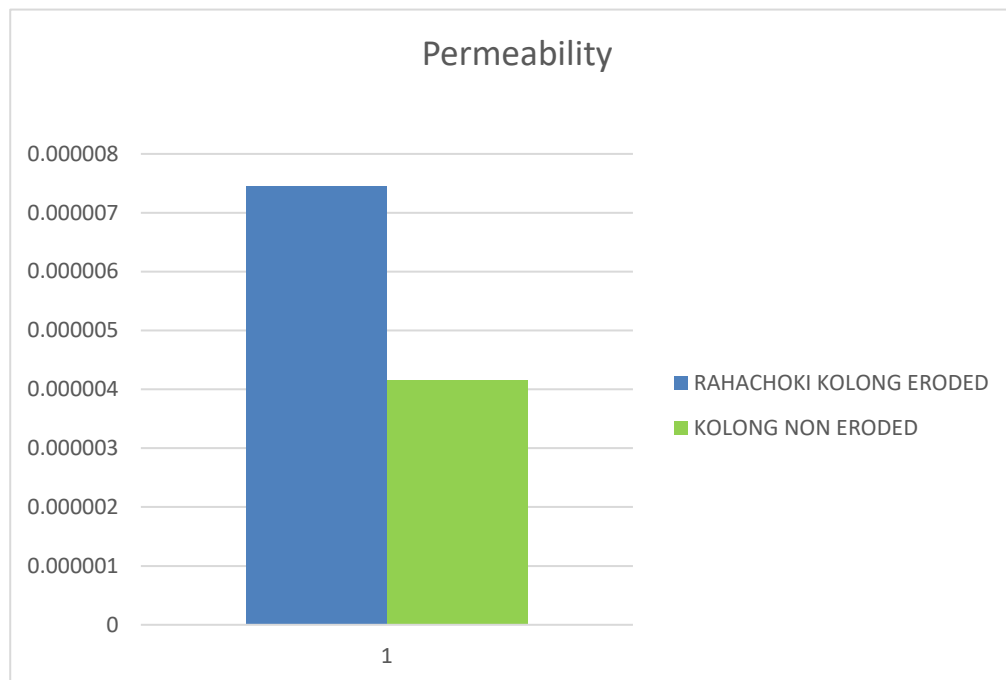
Fig 5.7: Coefficient of permeability of soil sample

The result of falling head permeability test performed on eroded (Rahachoki) and non eroded (kolongpar) samples are listed below

K_{avg}(eroded)	7.44×10^{-6}
K_{avg} (non eroded)	4.14×10^{-4}
